Las Vegas Wash Revegetation Program 2000-2010

January 25th, 2010

Jason R. Eckberg
Las Vegas Wash Coordination Committee
Southern Nevada Water Authority

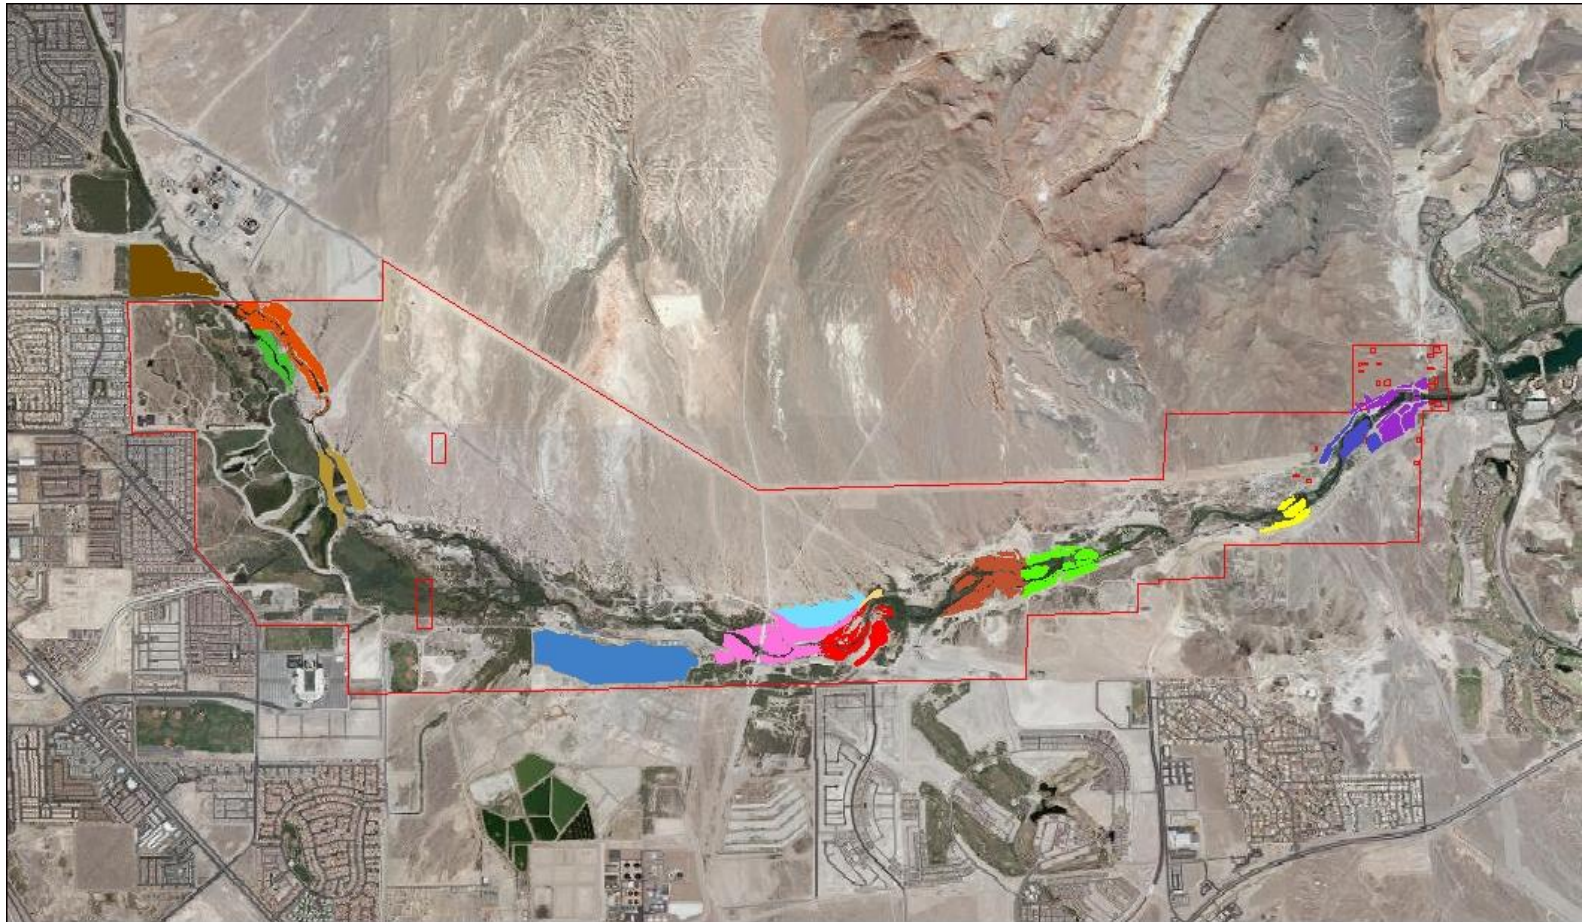
2010 Revegetation Areas	
 	Bostick Weir
 	Calico Ridge Weir
 	Clark County Water Reclamation District
 	Cottonwood Cells
 	DU Wetlands No. 2 Weir
 	Demonstration Weir
 	Historic Lateral Weir
 	Monson and Visitor Center Weirs
 	Pabco Road Weir
 	Powerline Crossing Weir
 	Rainbow Gardens Weir
 	Site 108
 	Site 111
 	Upper Diversion Weir
 	Clark County Wetlands Park and private property boundaries

For planning purposes only
 Prepared by the Southern Nevada Water Authority
 Aerial Image taken September, 2009

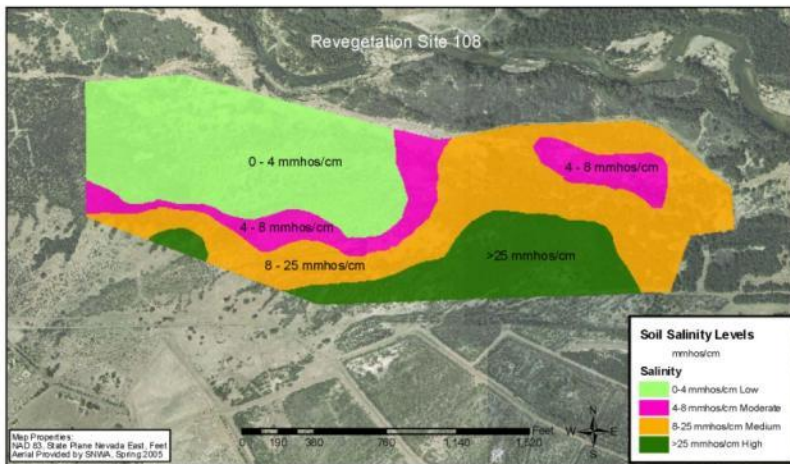
April 1, 2006
Soil Salinity Map

Southern Nevada Water Authority
Las Vegas Wash Revegetation Design

- Most areas dominated by salt cedar
 - Majority of sites cleared as part of construction process
- Soil sampling
 - Salinity
 - Texture
- Depth to Water

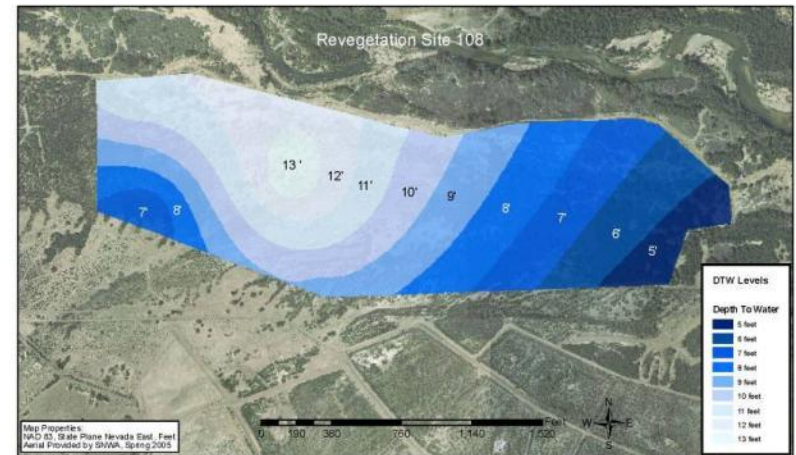
April 1, 2006
Surface To Water
Table Depth Map

Southern Nevada Water Authority
Las Vegas Wash Revegetation Design

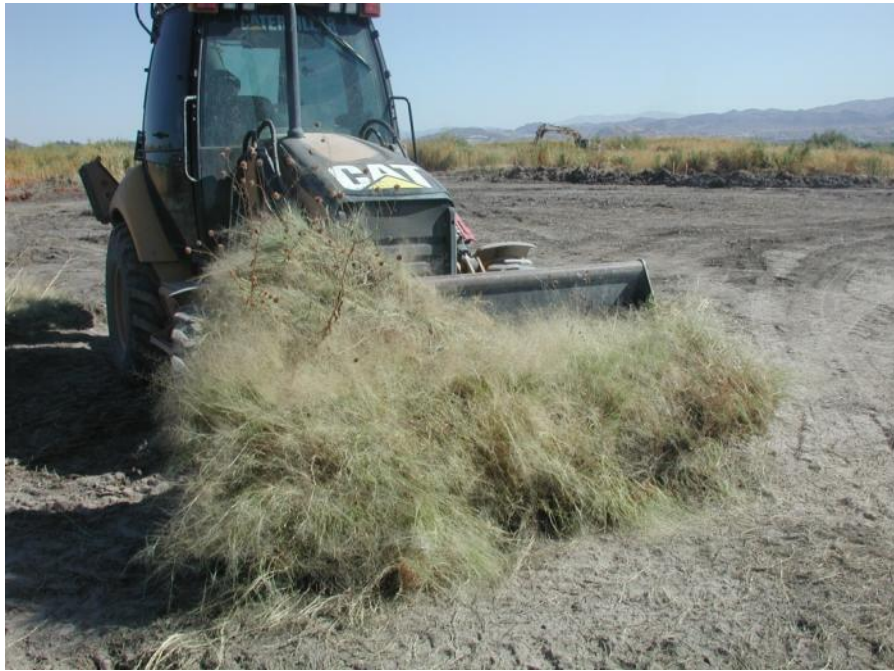
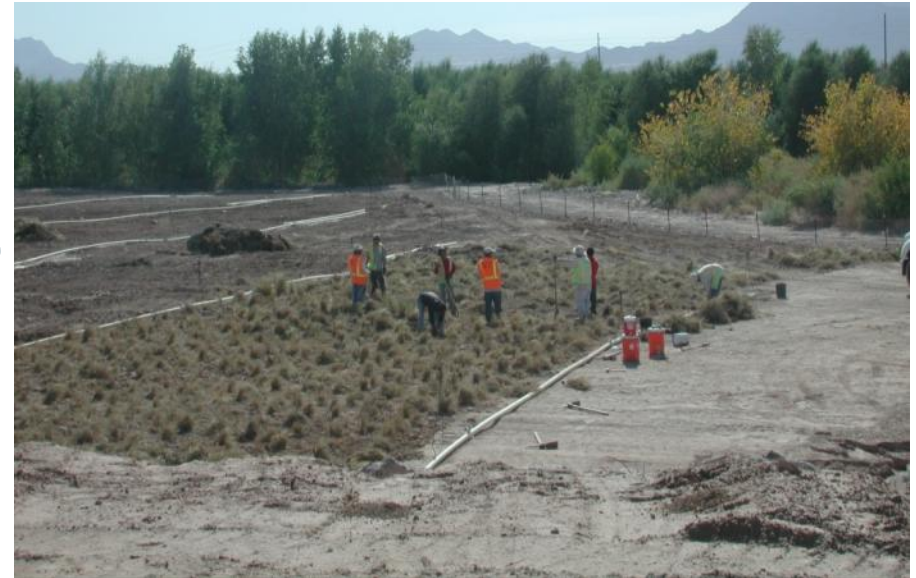
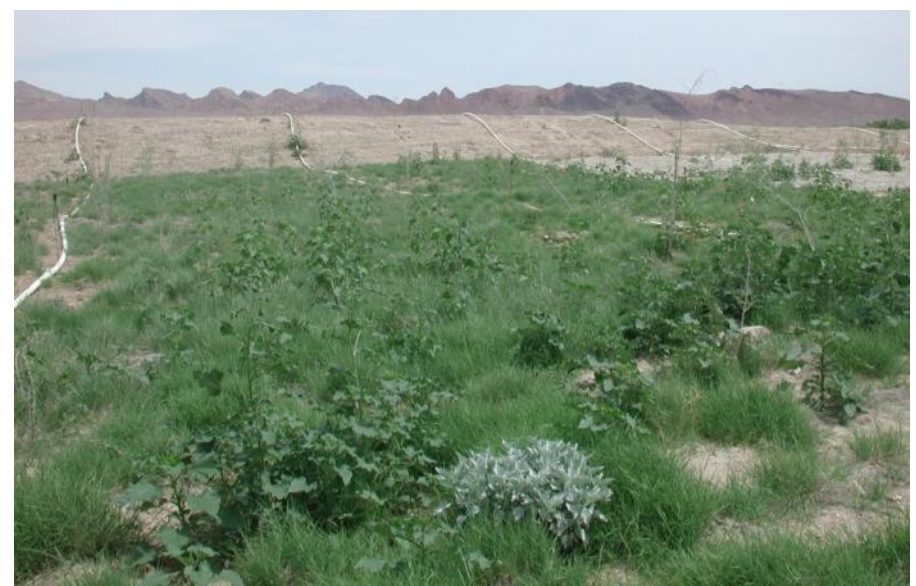
- **Transplants**
 - **Bulrush (*Schoenoplectus* spp.)**
 - **Saltgrass**

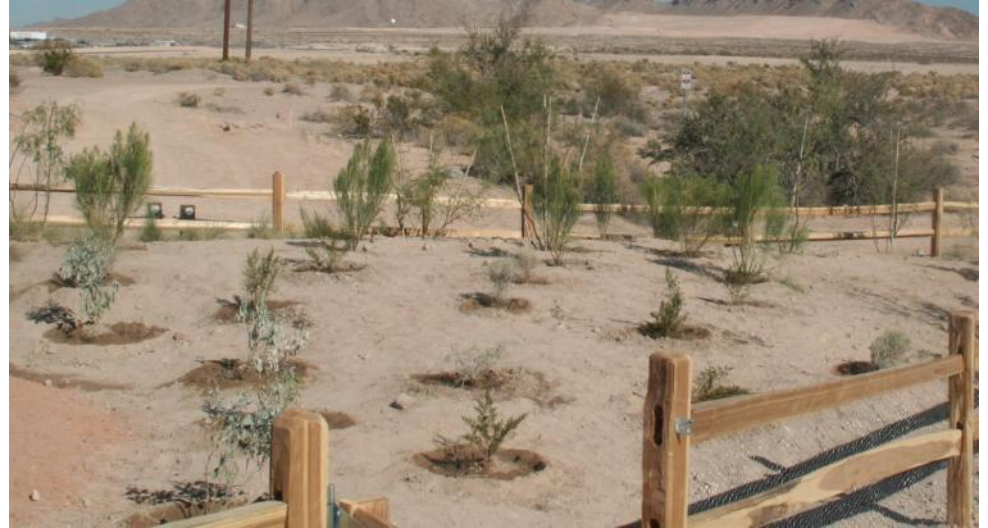
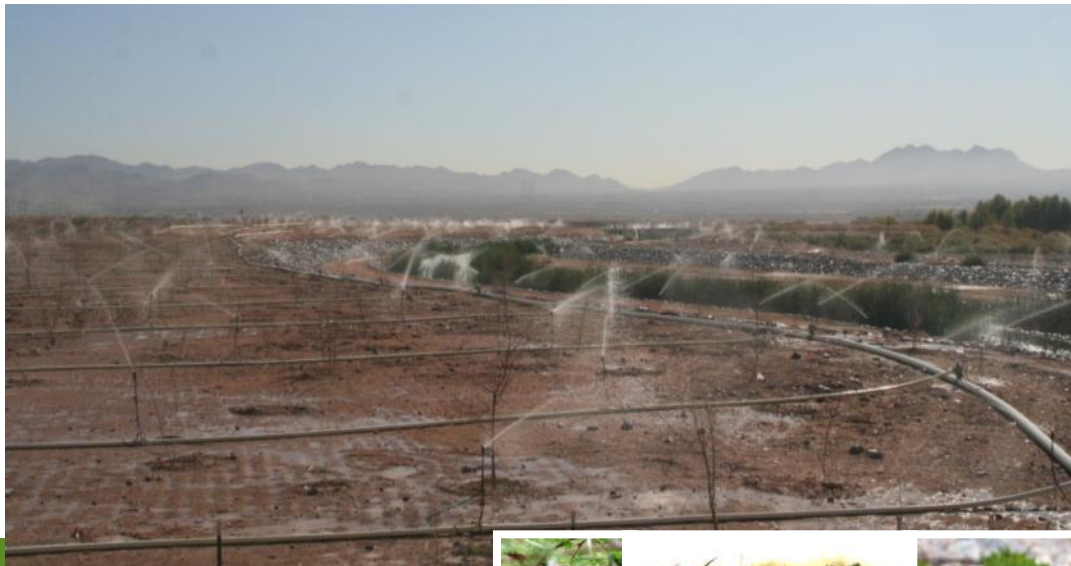
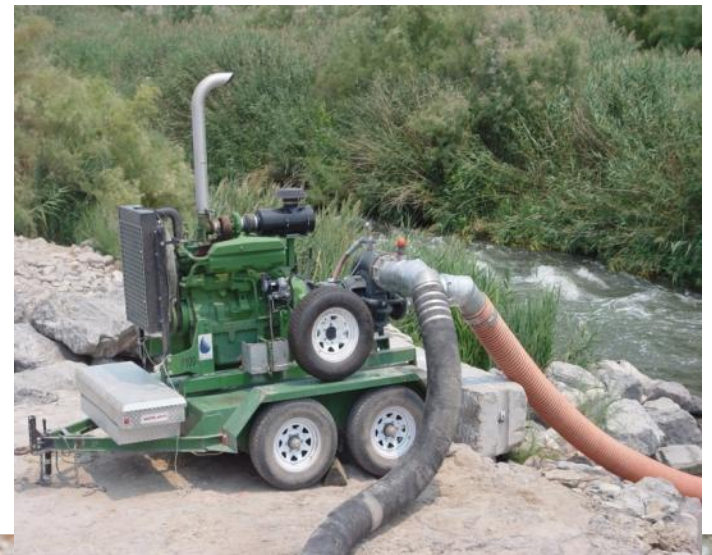
- Irrigation
 - Spray
 - Certa-lok irrigation pipe
 - Mobile pump
 - Drip

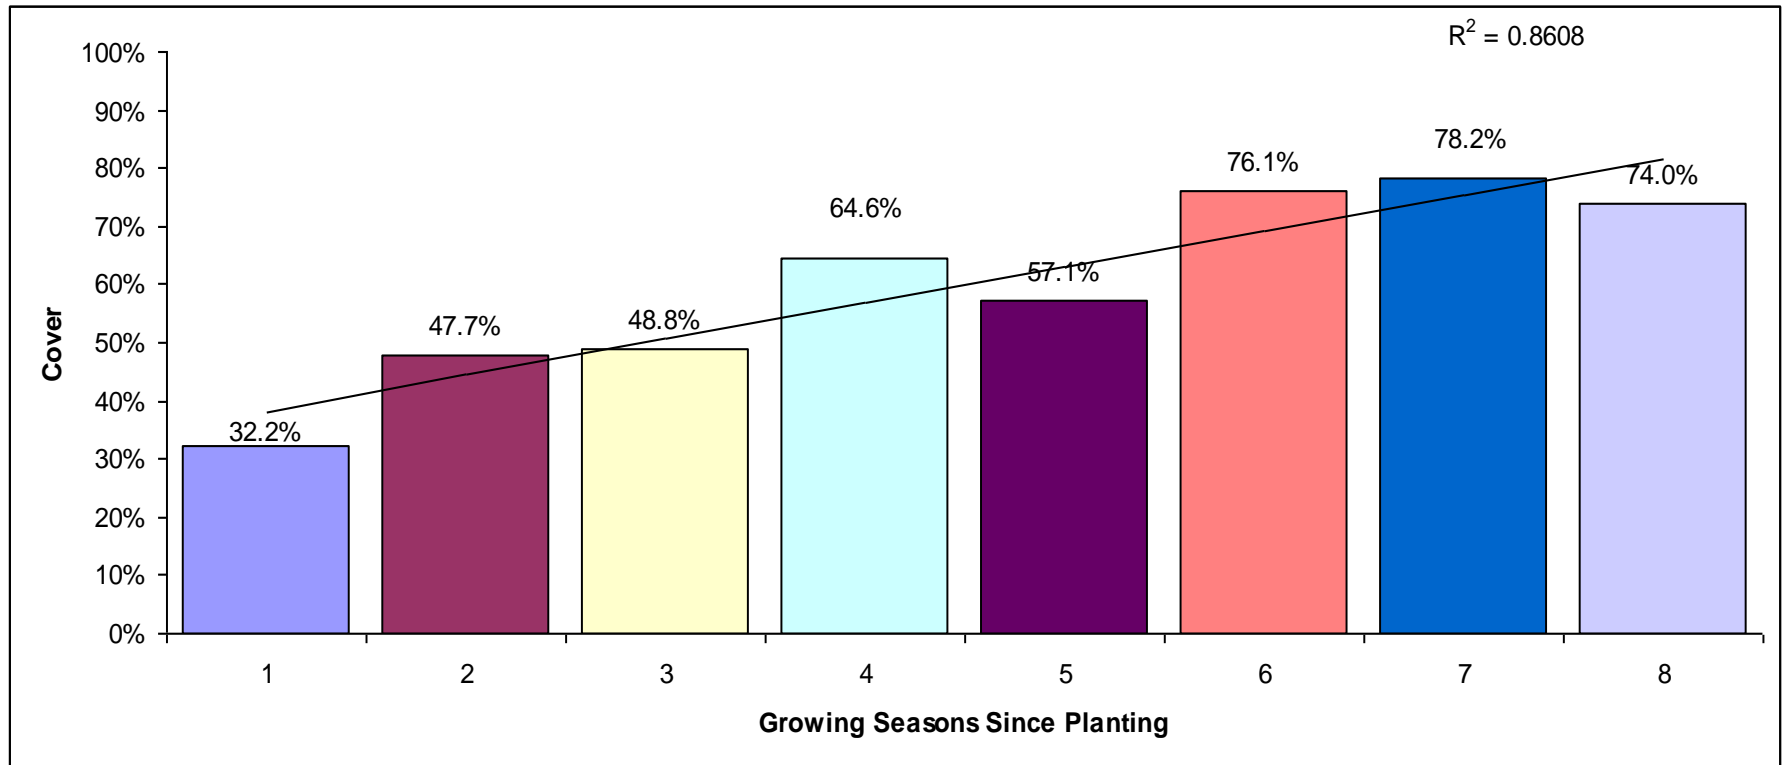
- Site Cover Trend

- **Criteria**
 - Cover
 - Survivorship
 - Invasive species cover
 - Species richness
- **Techniques**
 - Line-intercept
 - Cover Class
- **Additional Data**
 - Wildlife usage
 - Site changes

Cover Rank	Value Range	Midpoint
R	<<1%	0.1%
T	<1%	0.5%
1	1-5%	2.5%
2	5-25%	15.0%
3	25-50%	37.5%
4	50-75%	62.5%
5	75-100%	87.5%

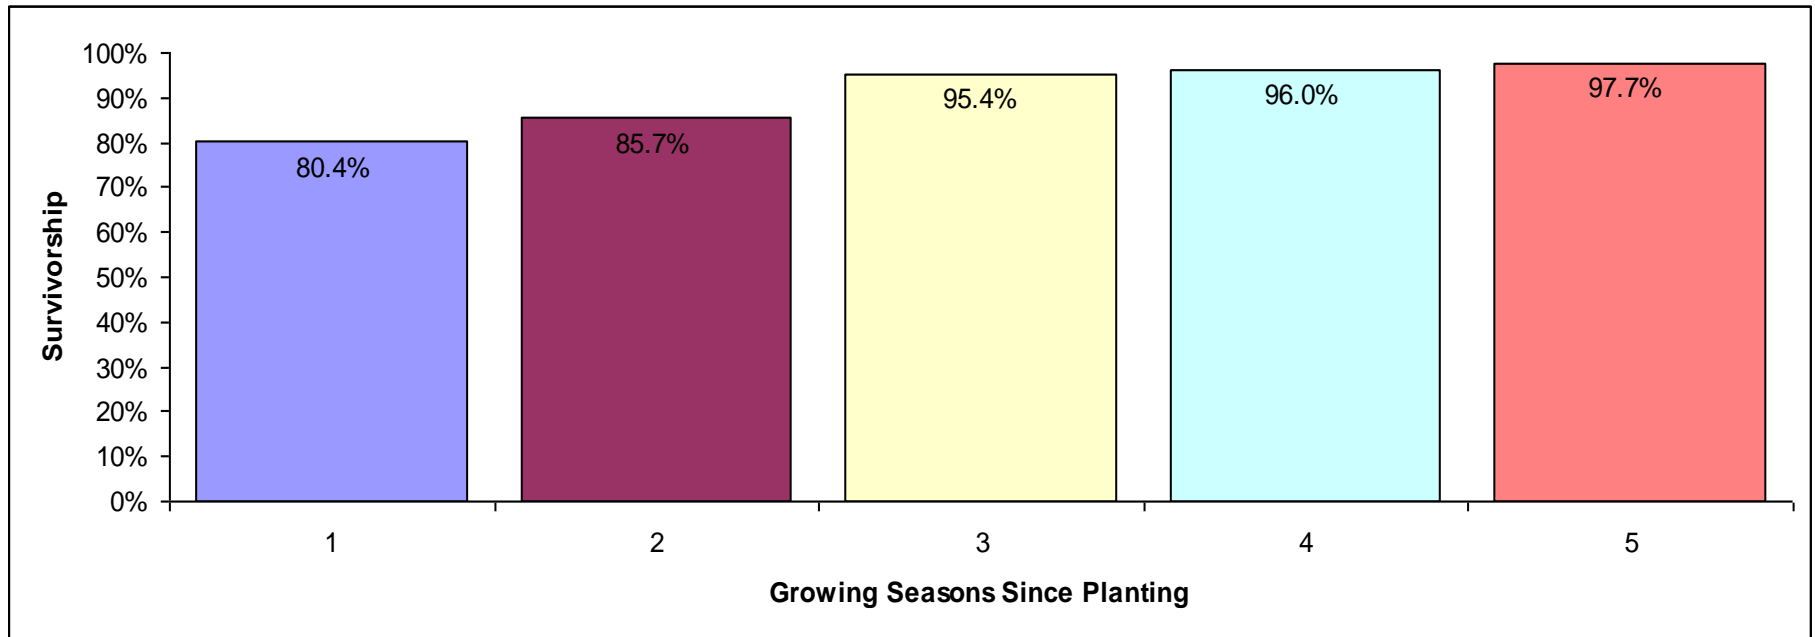
- Survivorship of planted plants

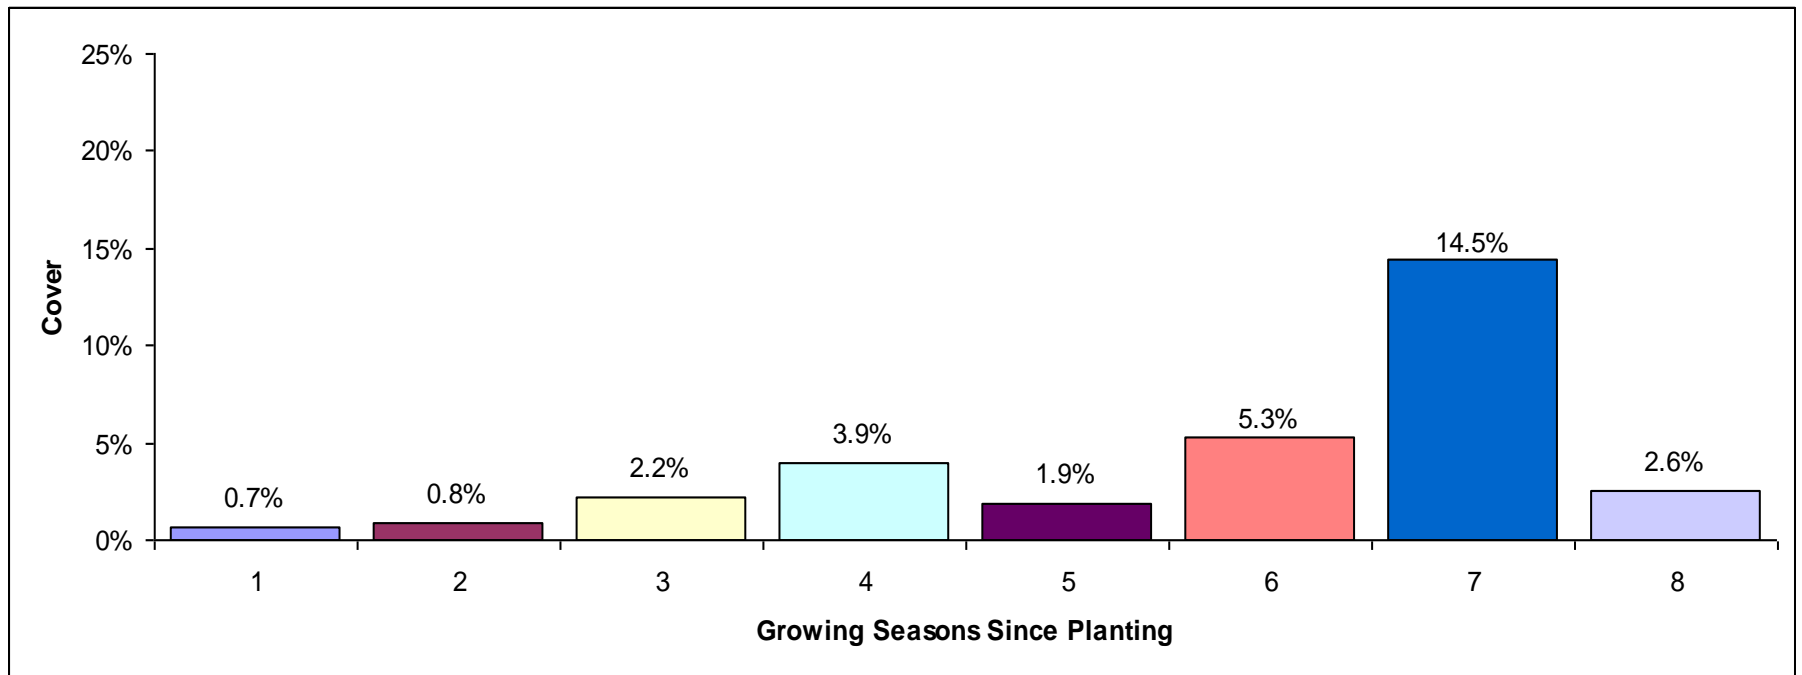
- Invasive species cover remains low

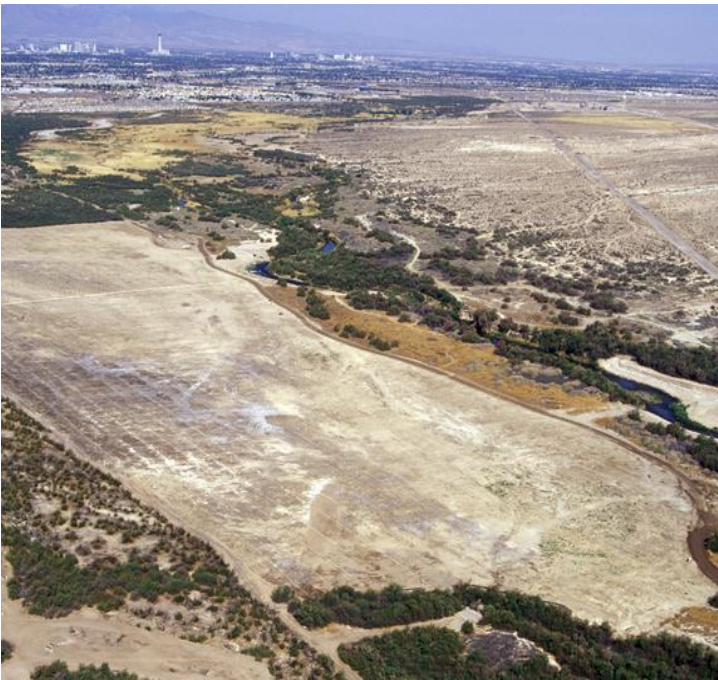
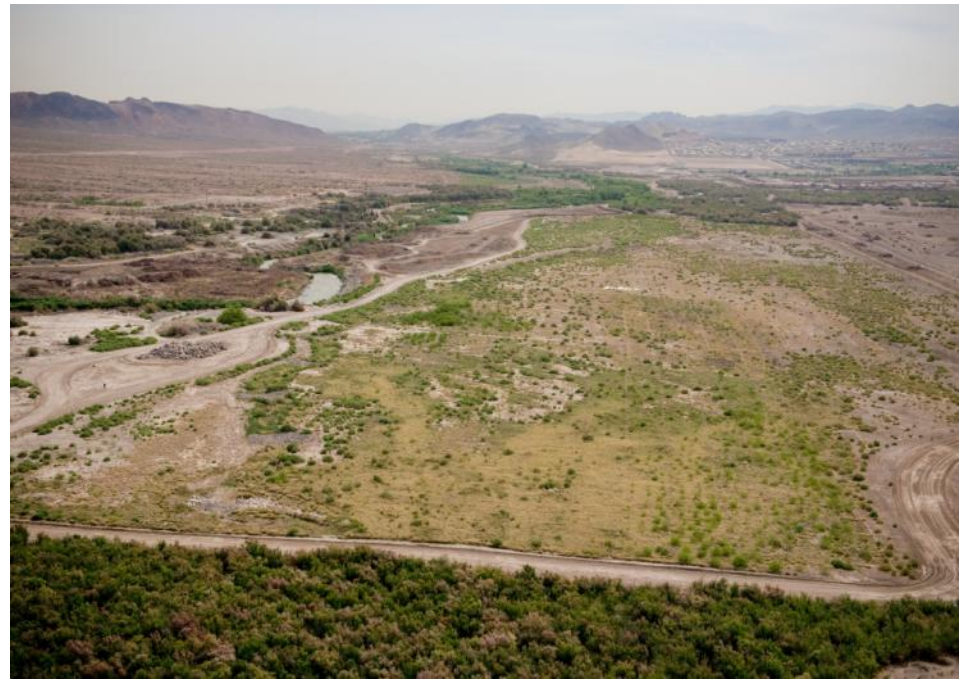
April, 2006

- **Site 108**
 - Non-wetland revegetation site
 - Not associated with Weir
 - Provides important buffer to Wash and increases wildlife habitat

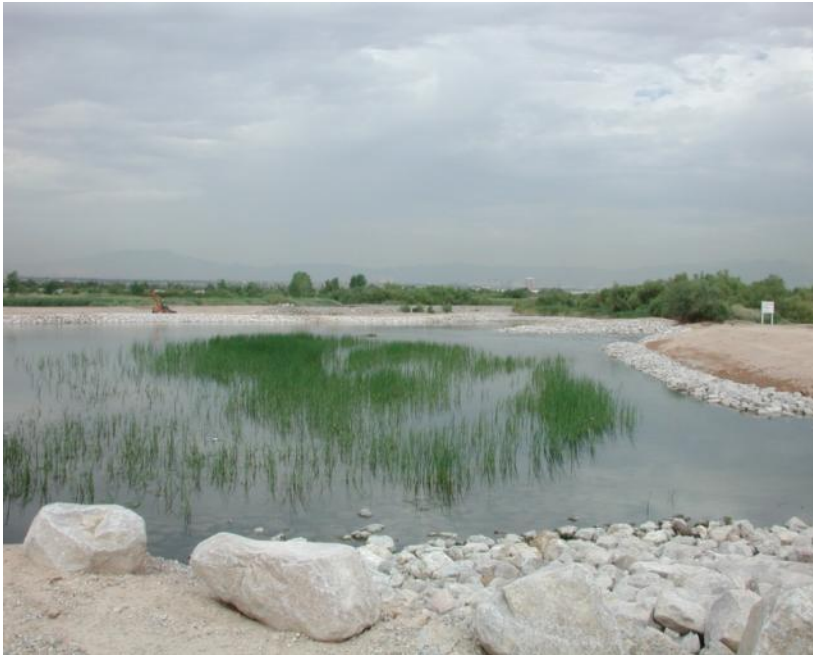
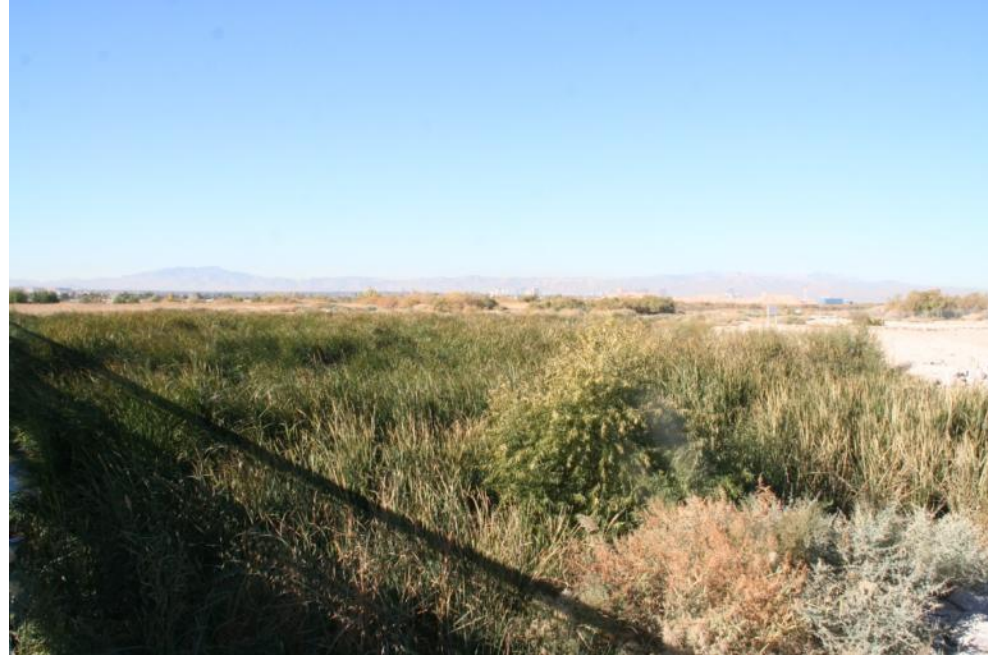
July, 2008

- **Upper Diversion Weir**
 - Pond located upstream of Weir completed in summer of 2008
 - Passive establishment of large cattail community
 - Provides food and shelter to a wide variety of bird species

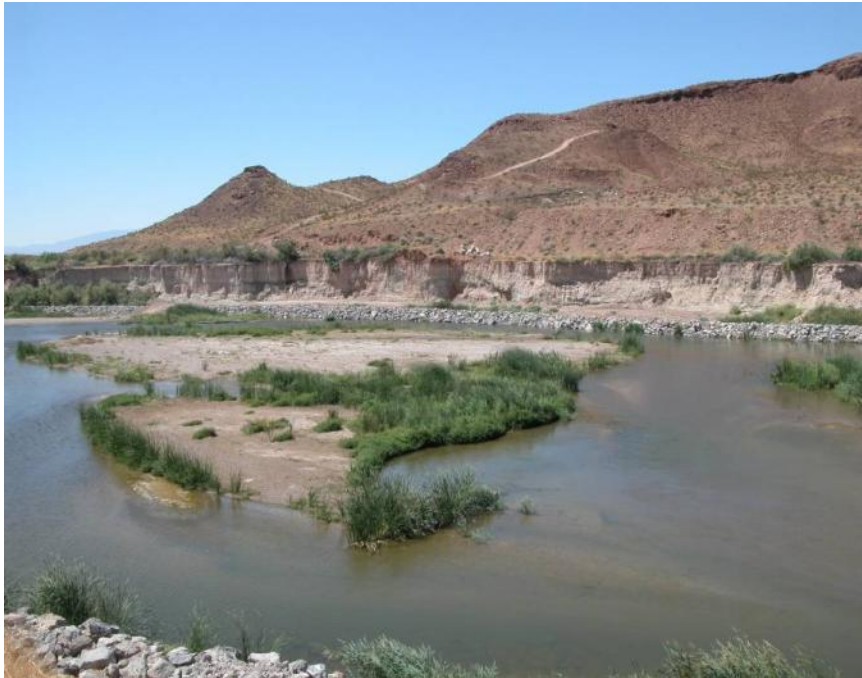
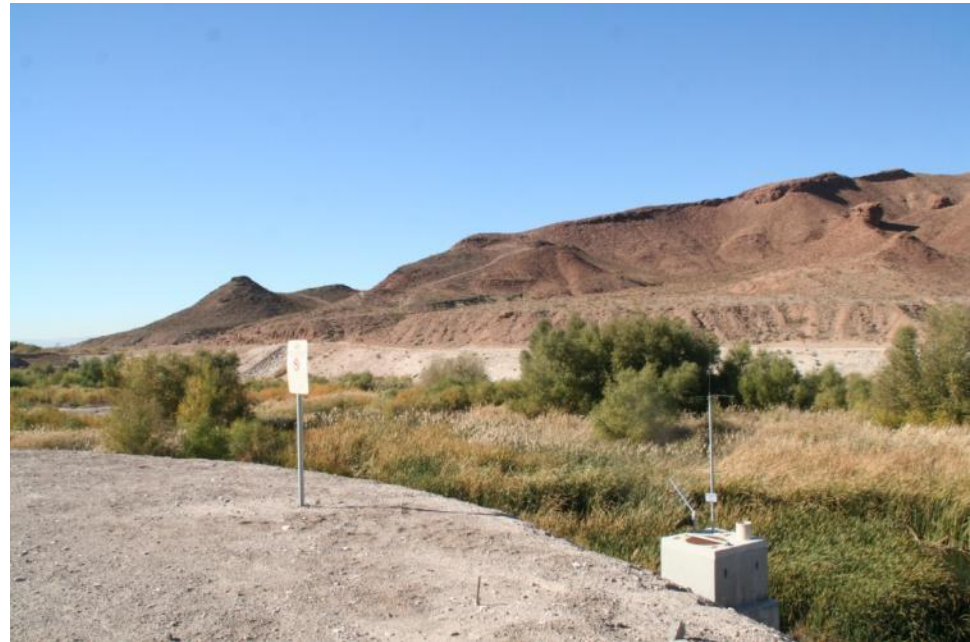
August, 2005

- **Rainbow Gardens Island**
 - Located upstream of Rainbow Gardens Weir
 - Area continues to grow as sediment gets deposited
 - Planted in 2005 when less than 2 acres, now approximately 4 acres
